Immingham Eastern RoRo Terminal

Preliminary Environmental Information: Appendix 12.1 Phase 1 Desk Study

Phase 1 Geo-Environmental and Geotechnical Desk
Study

Project number: 60664611

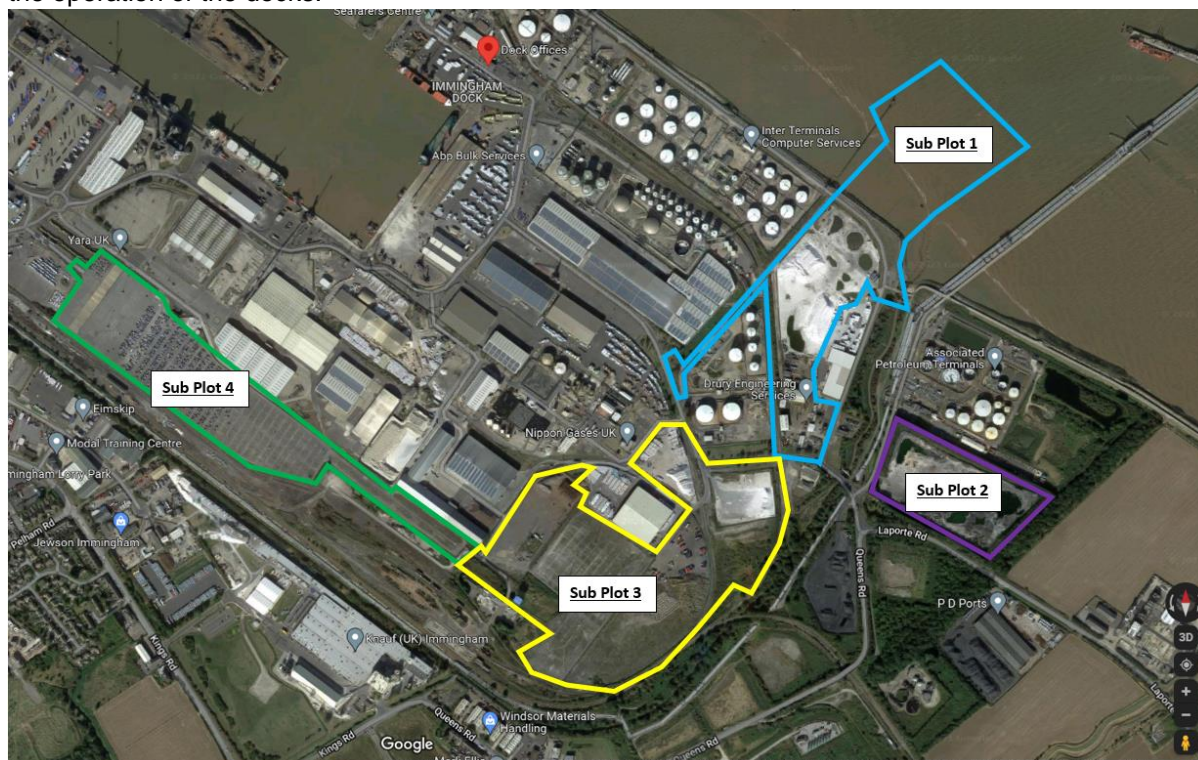
Figure 1 – Sub Plots

Observations from the site visit are split into 4 sub plots which are shown in **Figure 1**. Details of each sub plot are summarised here:

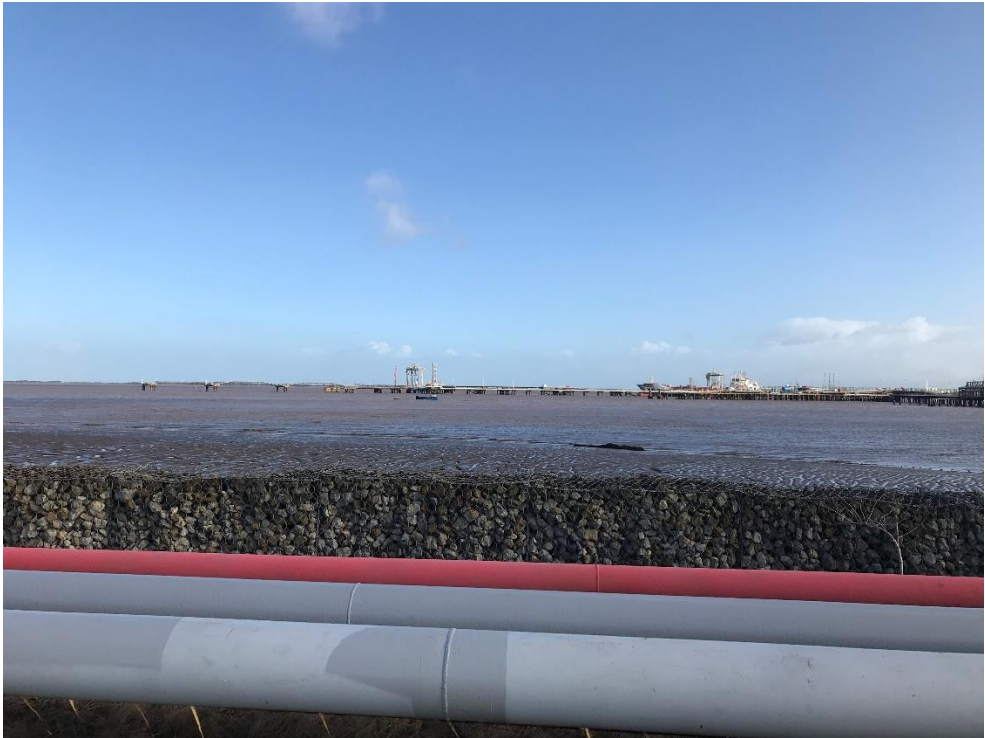
AECOM		PHOTOGRAPHIC LOG	
Client Name: Associated British Ports		Site Location: Project Sugar – Port of Immingham	Project No. 60664611
Photo No. 1	Date: 21/10/2021

Direction Photo Taken:			
North			
Description			
Sub Plot 1 – Looking north towards Humber Estuary/Proposed Terminal Jetty

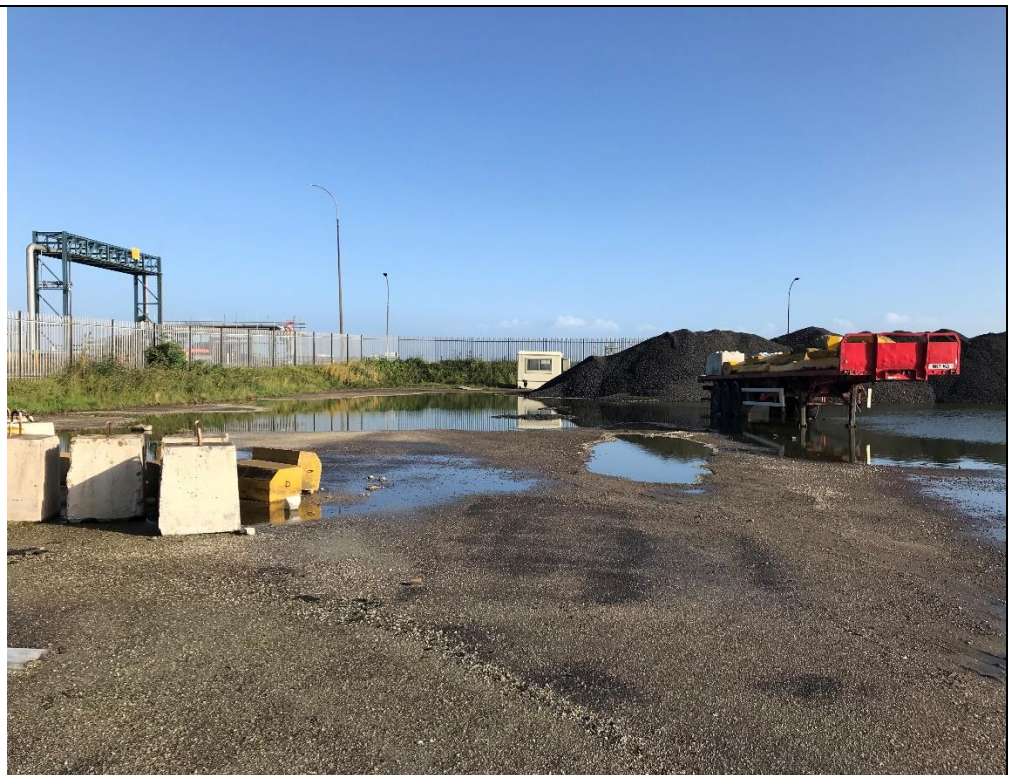
Photo No. 4

Sub Plot 1 – Northern storage yard containing stockpiles of blast furnace slag. Ponding present of recent rainfall.

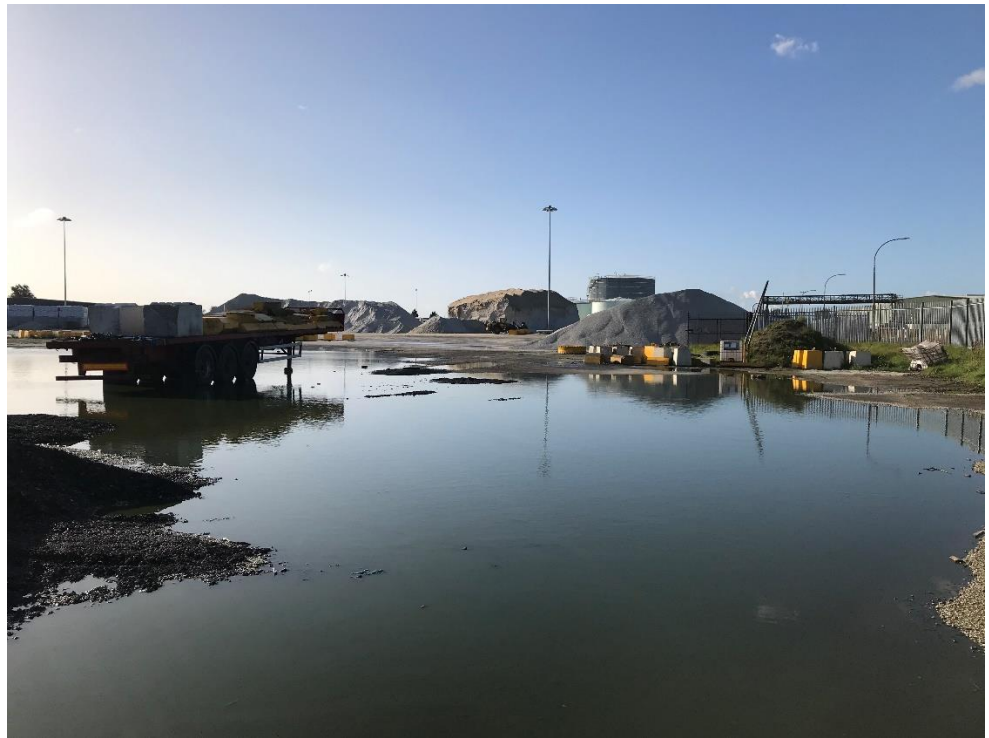
Sub Plot 1 – Rainwater ponding in centre of northern storage yard. Stockpiles of pumice in the background.

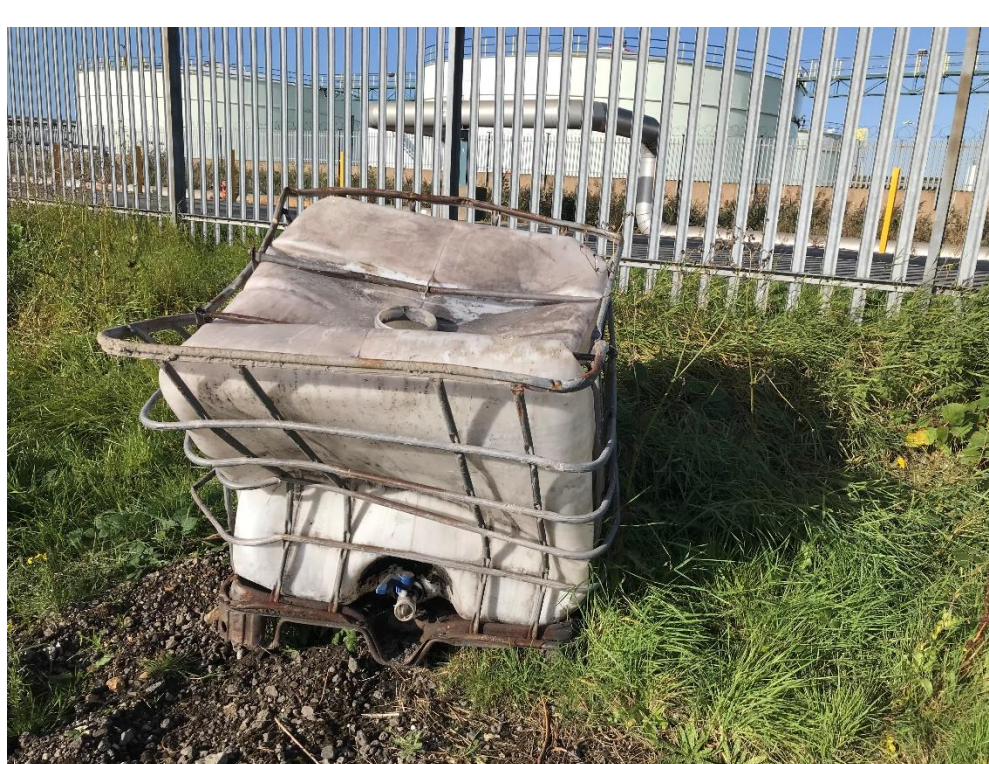
Photo No. 6
Date: 21/10/2021

Sub Plot 1 – Abandoned (empty) IBCs in northern storage yard.

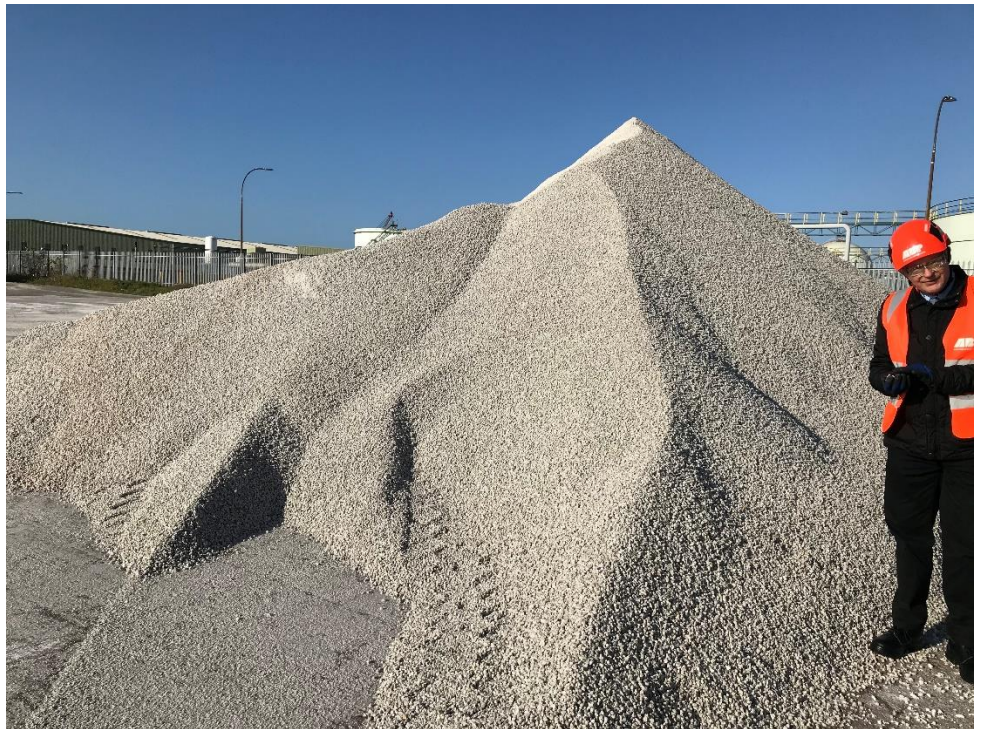
Sub Plot 1 – Stockpile of pumice in northern storage yard.

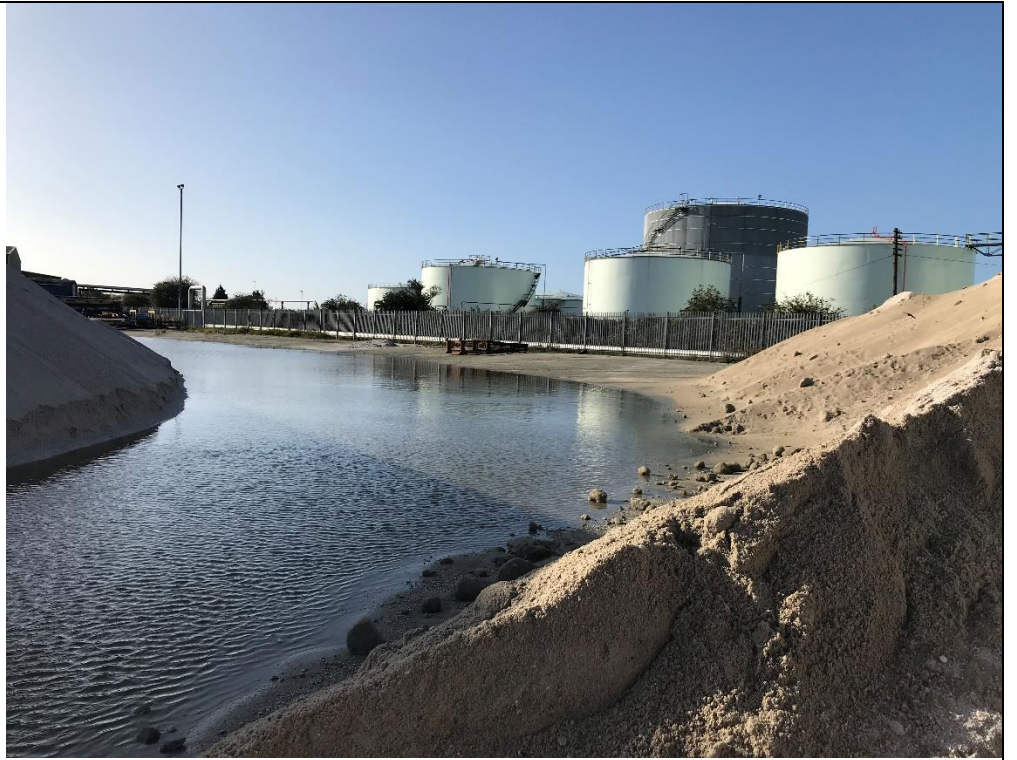
Photo No. 8 **Date: 21/10/2021**

Sub Plot 1 – Surface water ponding between two pumice stockpiles in the northern storage yard.

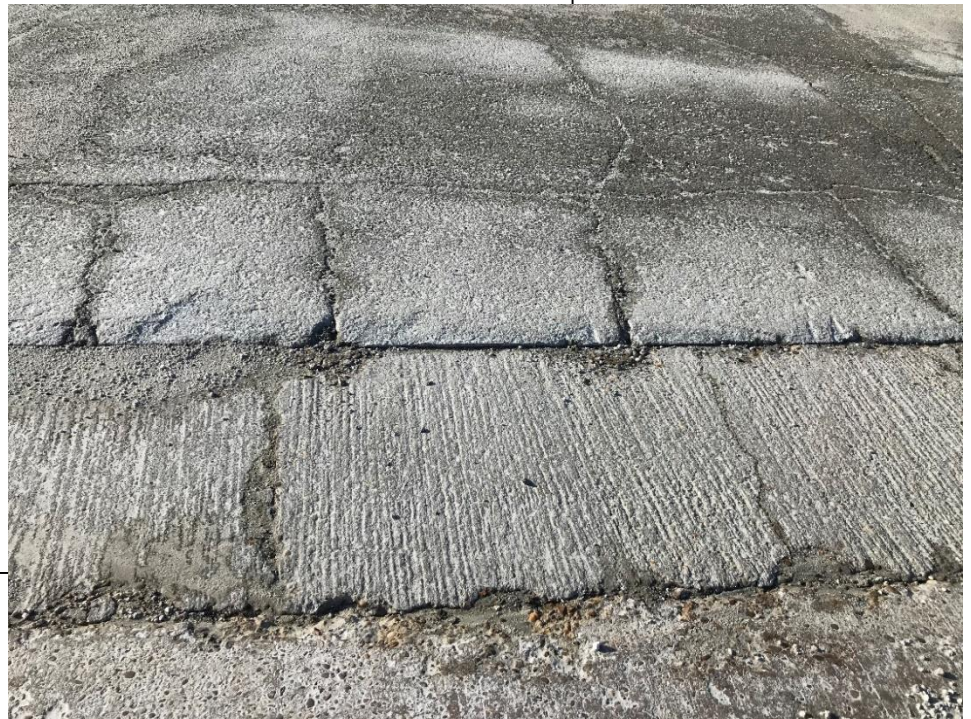
Sub Plot 1 – Condition of hard standing across the northern storage yard.

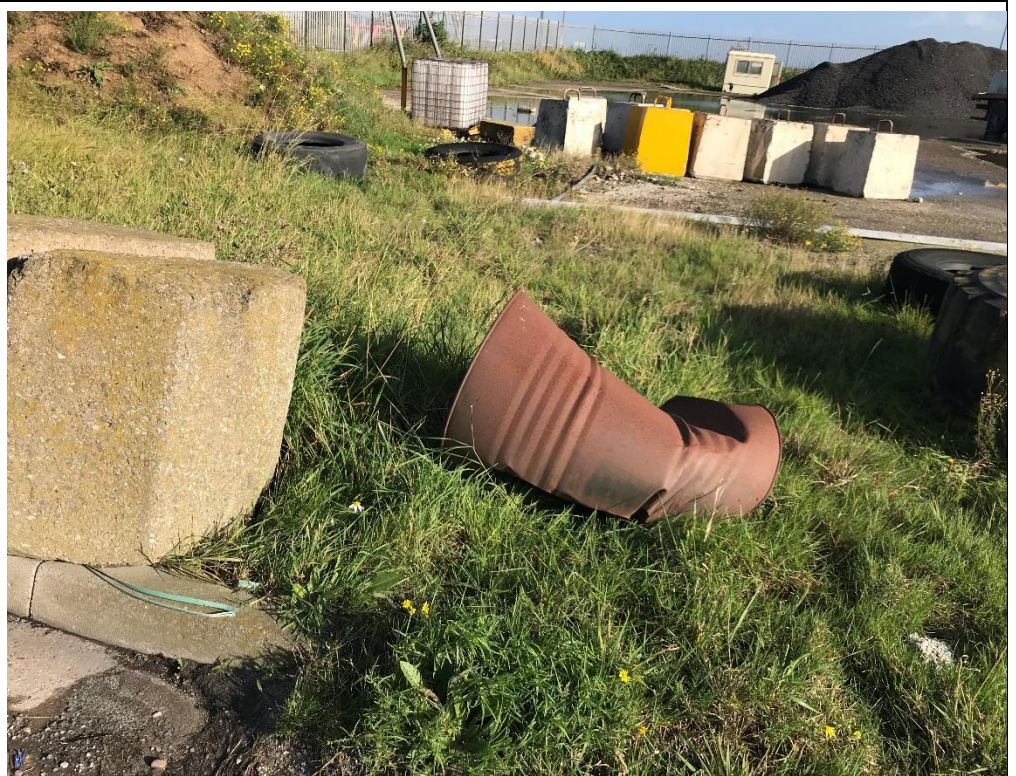
Photo No. 10
Date: 21/10/2021

Sub Plot 1 – Abandoned rusty/empty drum in northern storage yard.

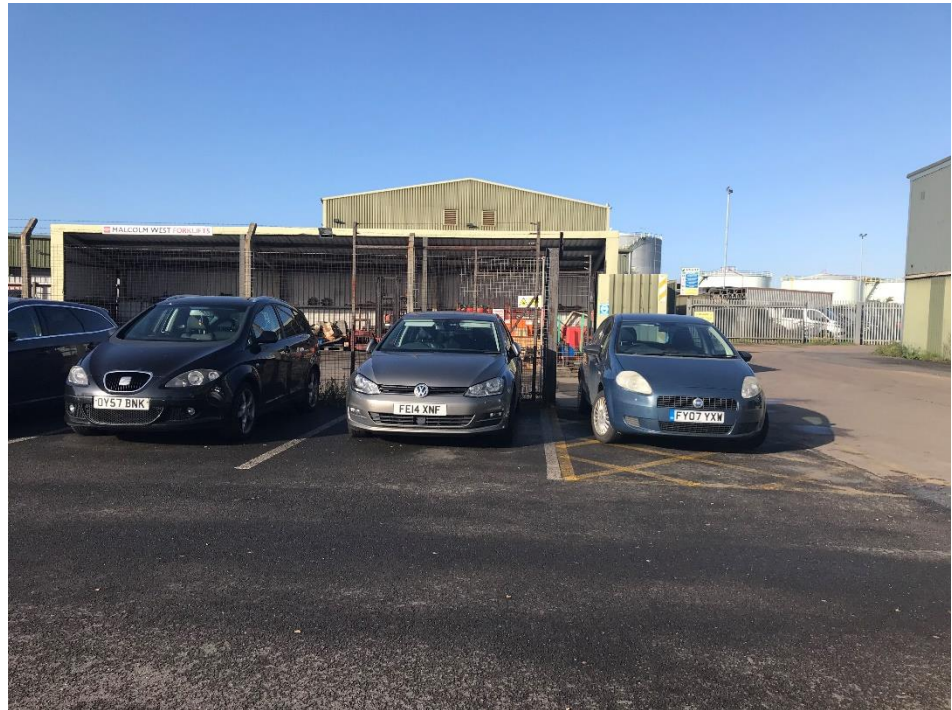
- The southern section of the plot was not accessible during the site visit as it is currently leased to Drury Engineering Services and PK Construction. Several intermediate bulk containers (IBCs), drums and gas cannisters were observed which appeared to be stored in a maintenance shed/yard type building. On the other side of the road which formed the eastern boundary of the plot were two large electrical substations.

Sub Plot 1 – Land leased to third party and could not be accessed. Suspected maintenance shed containing gas cylinders, IBCs and drums.

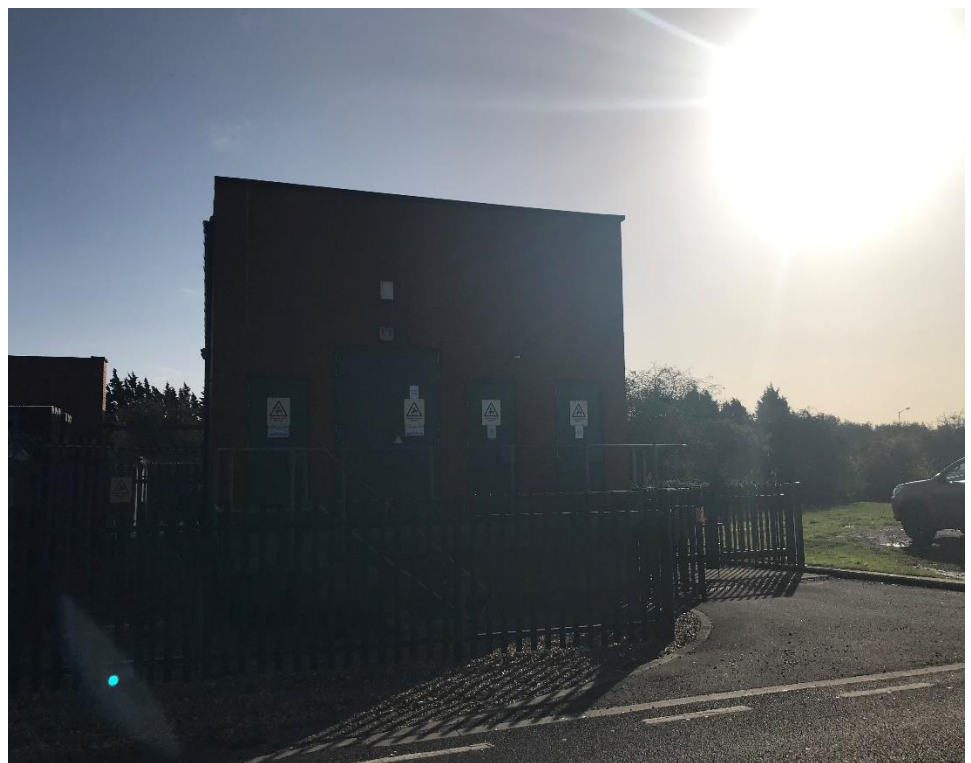
Photo No.
14

Sub Plot 1 – Large electricity substations situated immediately east of proposed site.

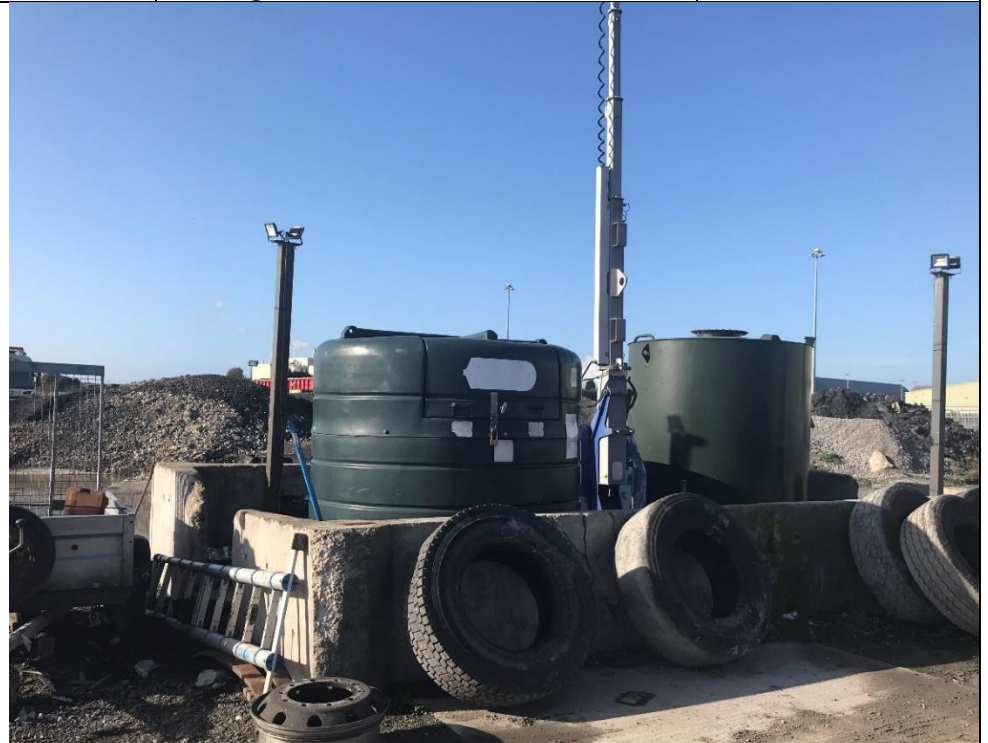
Sub Plot 3 – 2 no. storage tanks (diesel and oil) situated in centre of trailer yard. Contained in concrete bund which appears to be damaged.

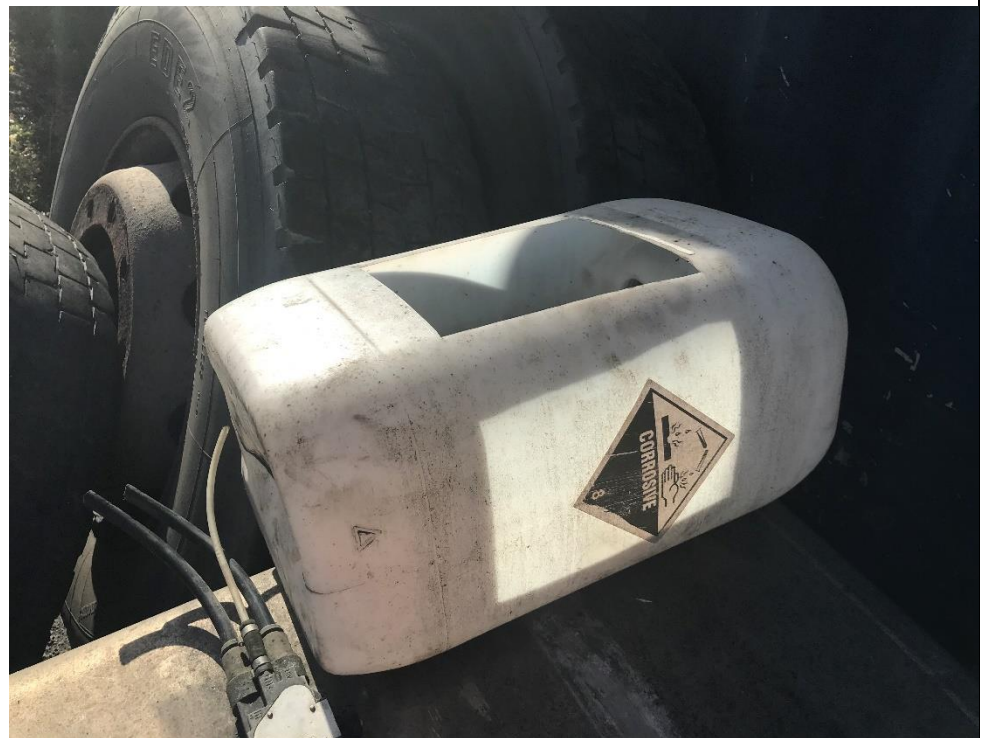
Photo No. 20 **Date:** 21/10/2021

Sub Plot 3 – Empty corrosive container, situated in trailer yard amongst old tires and empty fuel tanks.

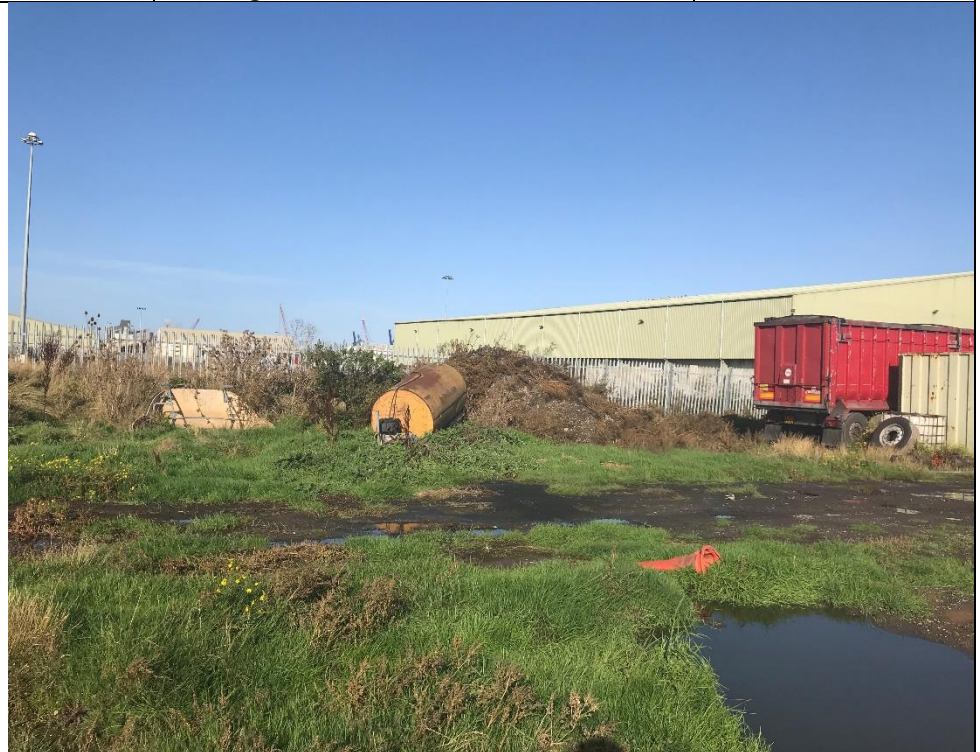
Sub Plot 3 – Overgrown grassland further south than trailer yard. Abandoned machinery.

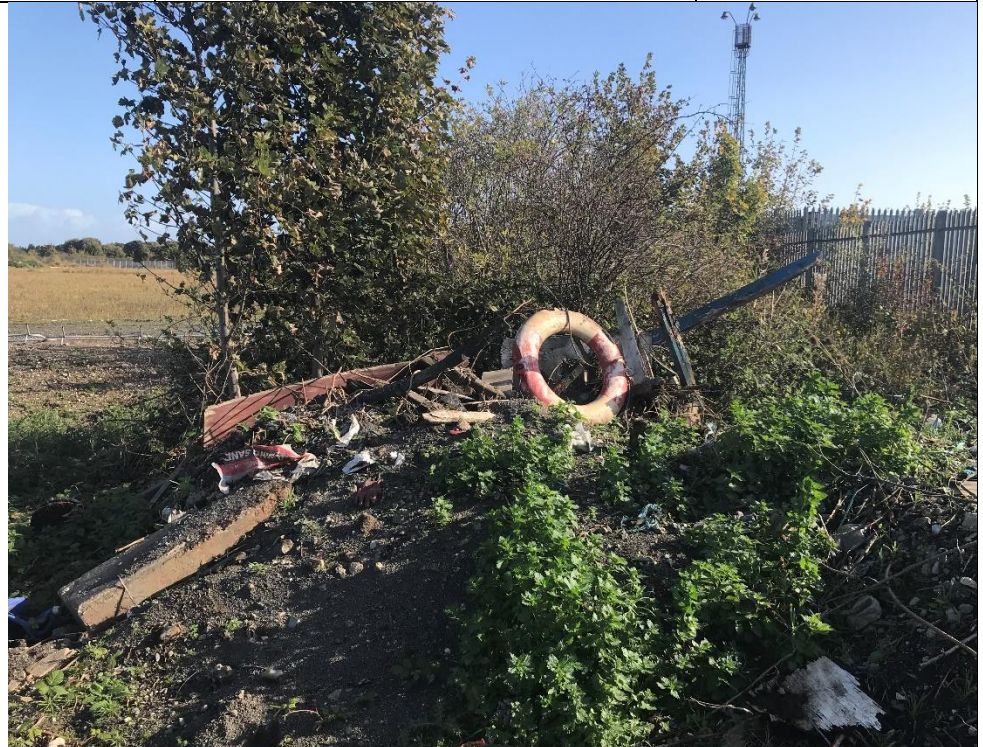
Sub Plot 3 – Stockpile towards southern end of vegetated area. Rubbish and rubble present.

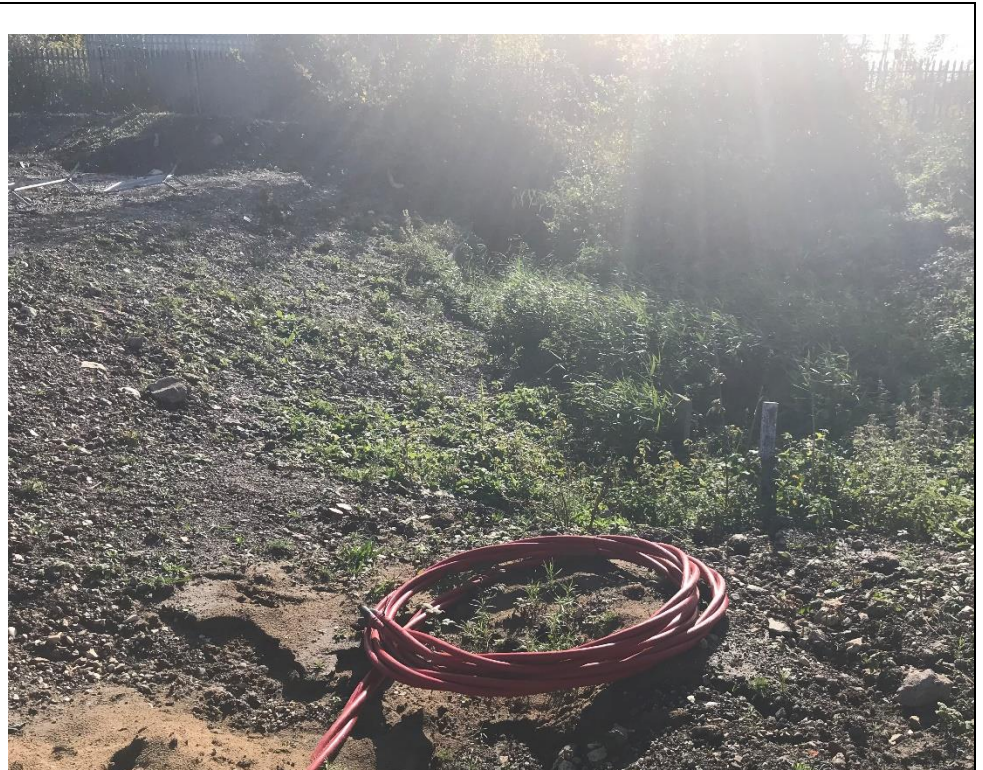
Photo No. 24 **Date:** 21/10/2021

Sub Plot 3 – Service duct / culvert below site (bringing power and water to the site).
